Real World Experiences With Real-Time On-Line Monitoring For Security and Quality. Detecting and Responding to Events.

By Dan Kroll, Karl King and Greg Klein

**Hach Homeland Security
Technologies**

**International Workshop on Water and Wastewater Security Incidents
May 28th-29th, 2009
Calgary, Canada**

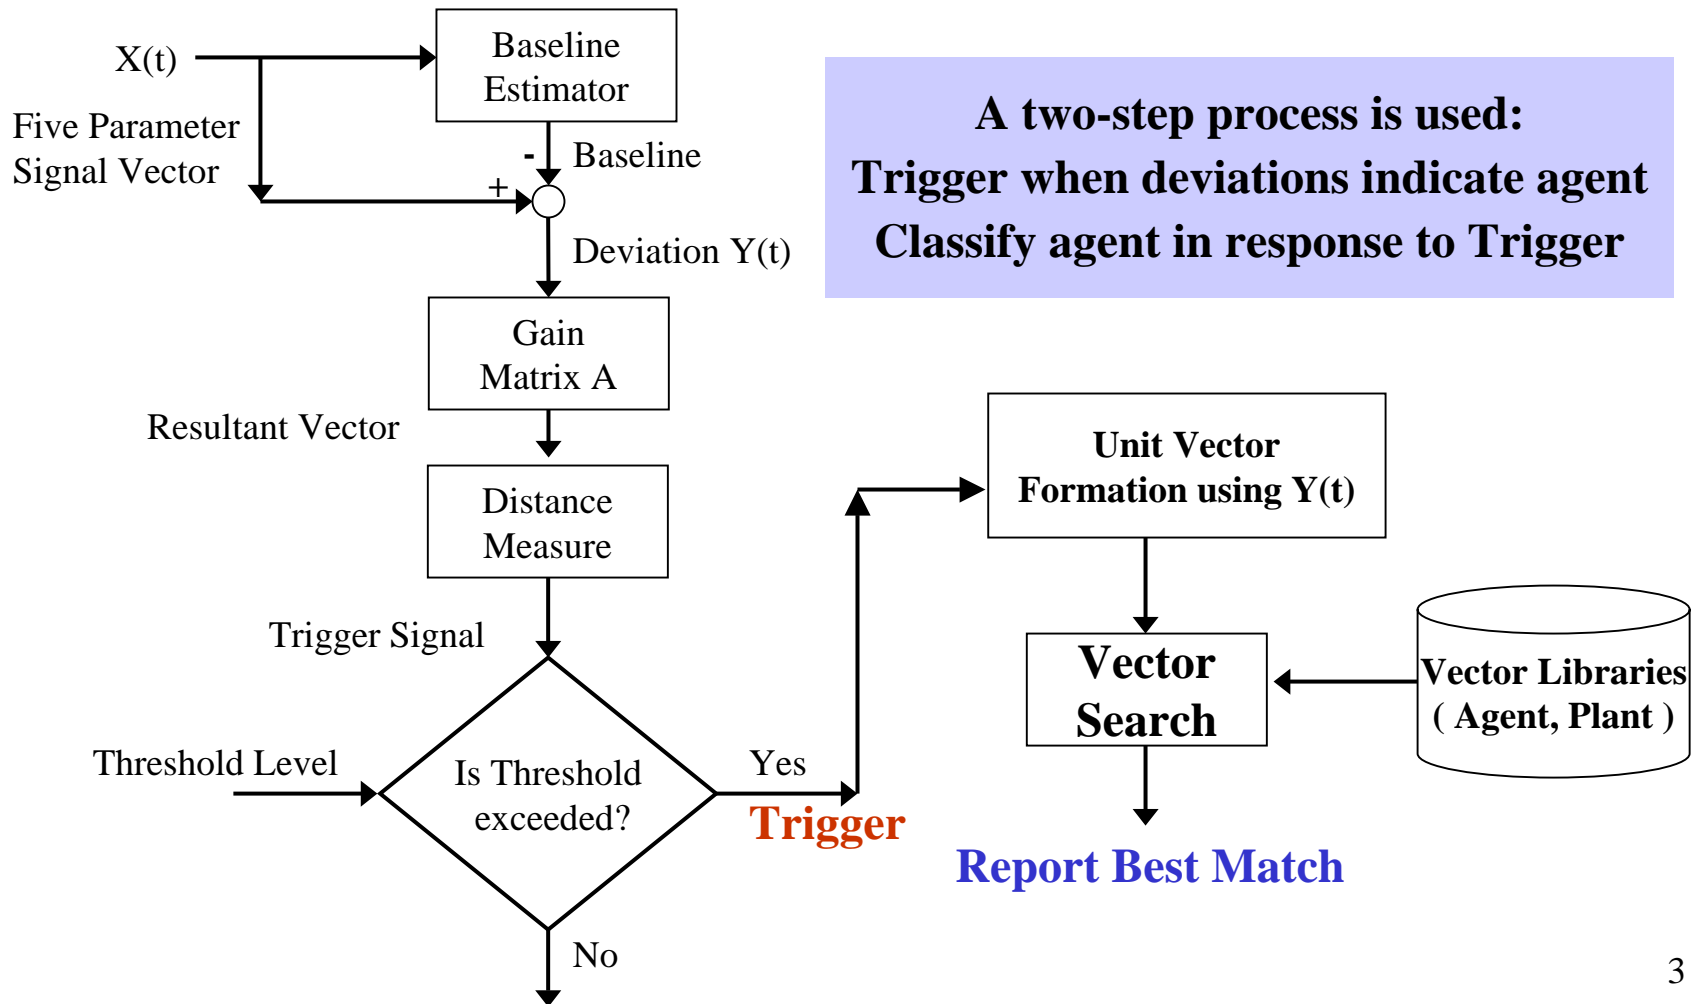
How the Algorithm Works

The Event Monitor analyzes plant data, alarms on significant deviations from baseline, reports the Event Name if found, and learns the event fingerprint if not already in the Plant Event Library.

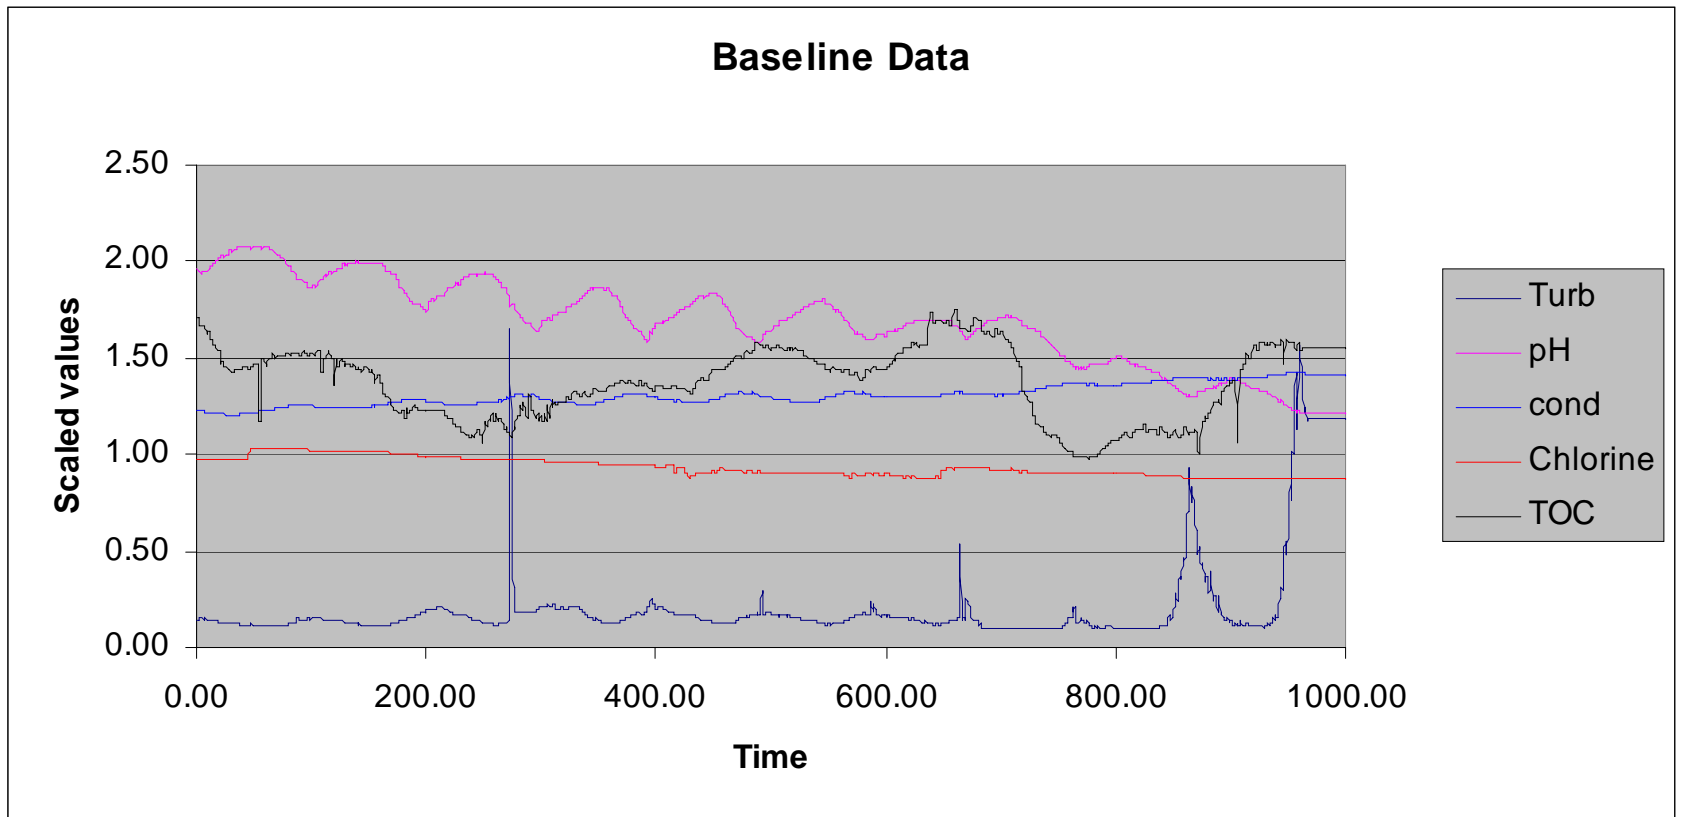
Raw Parameter Data for Trigger Analysis – Surface Water Facility

Raw data obtained in the distribution system is not static ...
where is the real baseline?

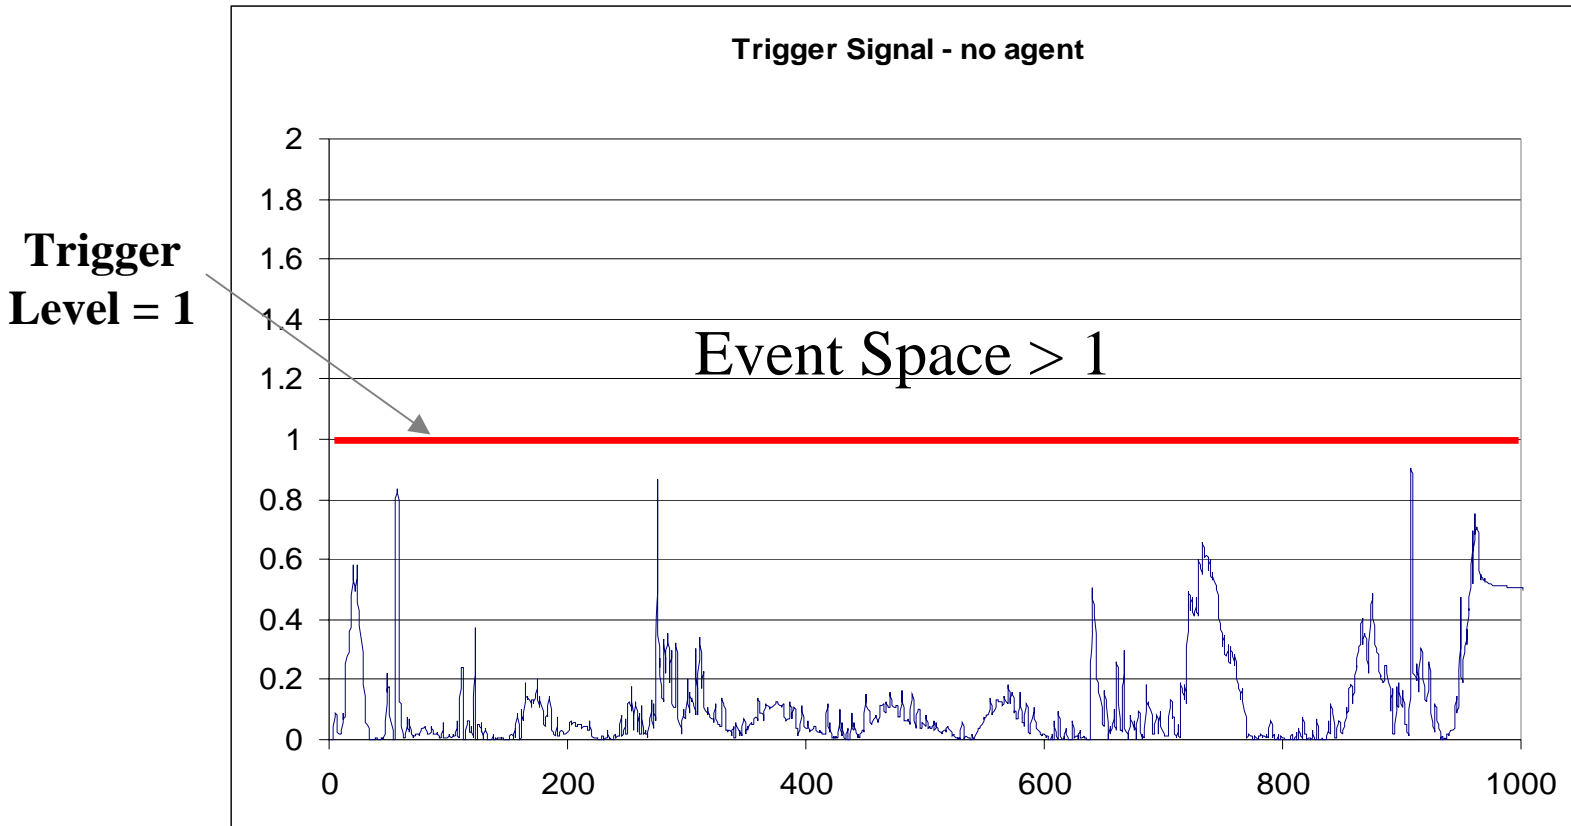
Trigger Signal w/ No Agent

During normal operation, process deviations are not larger than 1 on the trigger vector derived from grouped variations from baseline operation. The 5 parameters condensed into a single signal become easy to interpret.

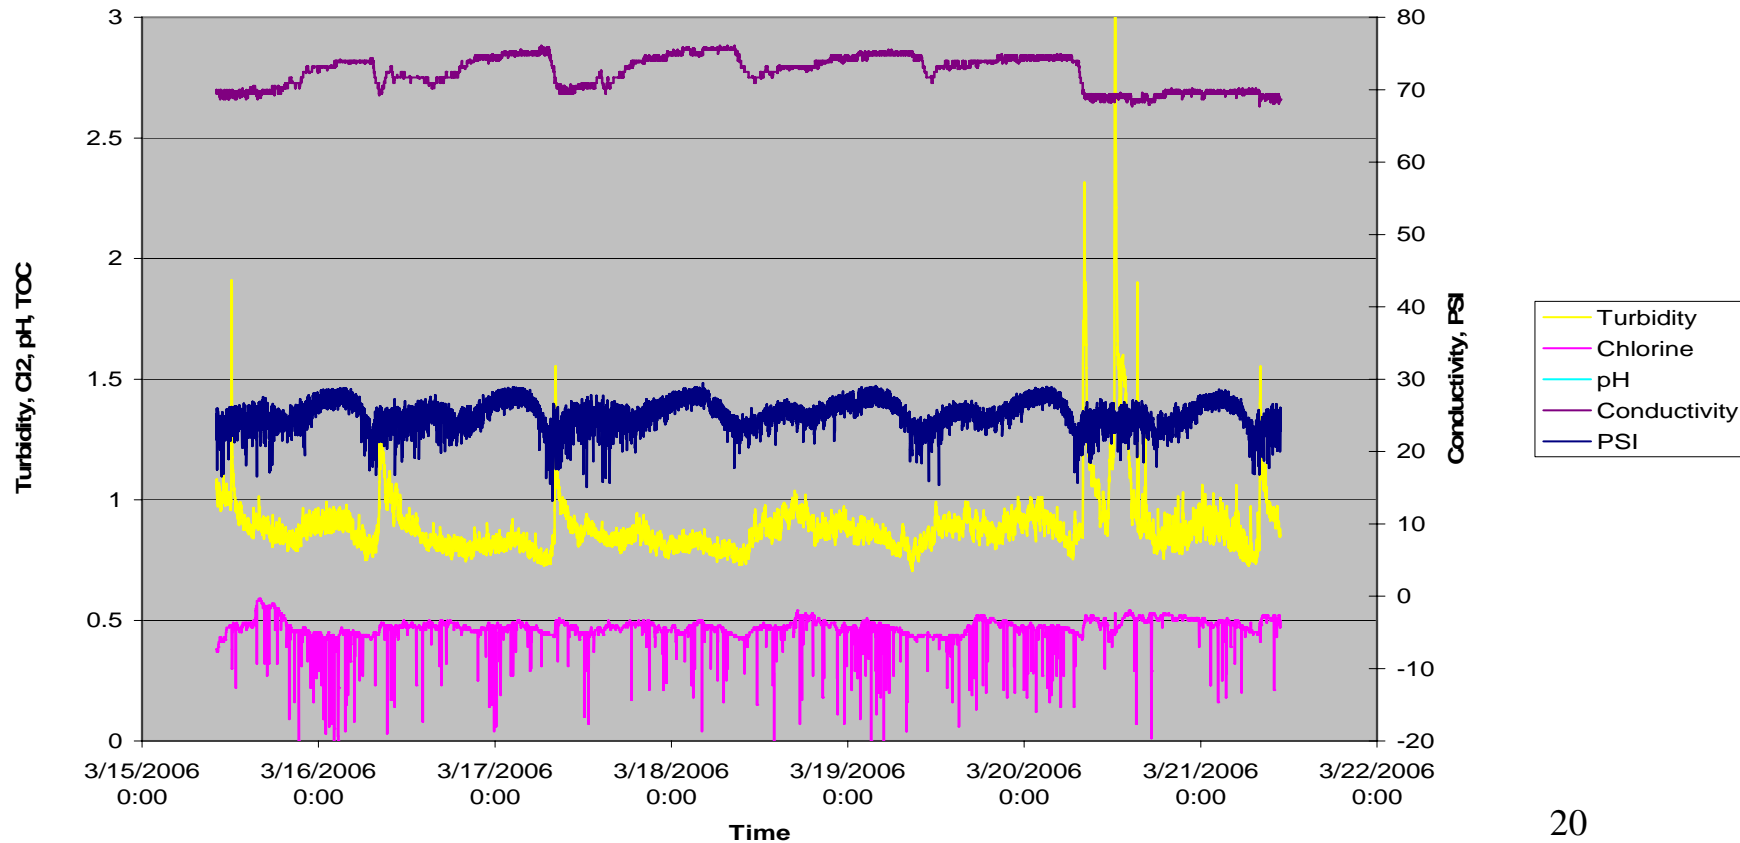
Turbidity, Cl2, pH, TOC, Conductivity, Pressure

Effects of Variable Demand

Daily events influencing turbidity, chlorine, pH and possibly conductivity are not completely understood but suspected to be caused by water demand fluctuations in the area.

May indicate need for flushing and chlorine booster.

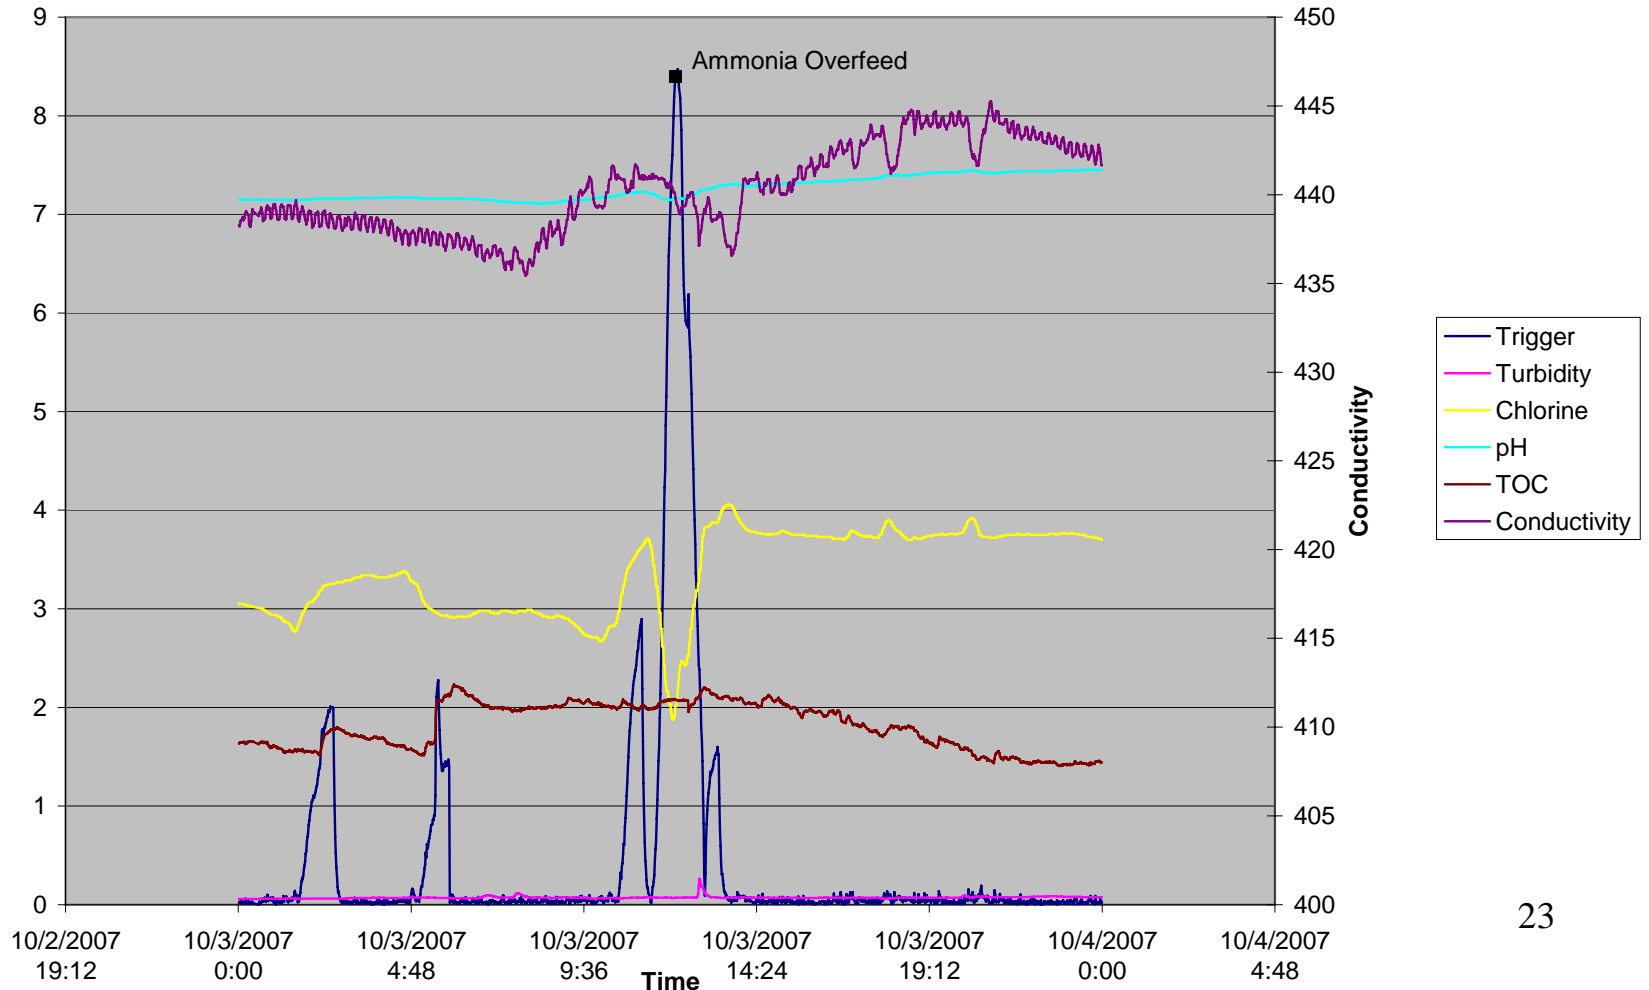
Ammonia Overfeed

On October 3rd, the plant experienced a brief ammonia overfeed. A pump was turned on and not switched off in time. There was a drop in chlorine and a small decrease in pH.

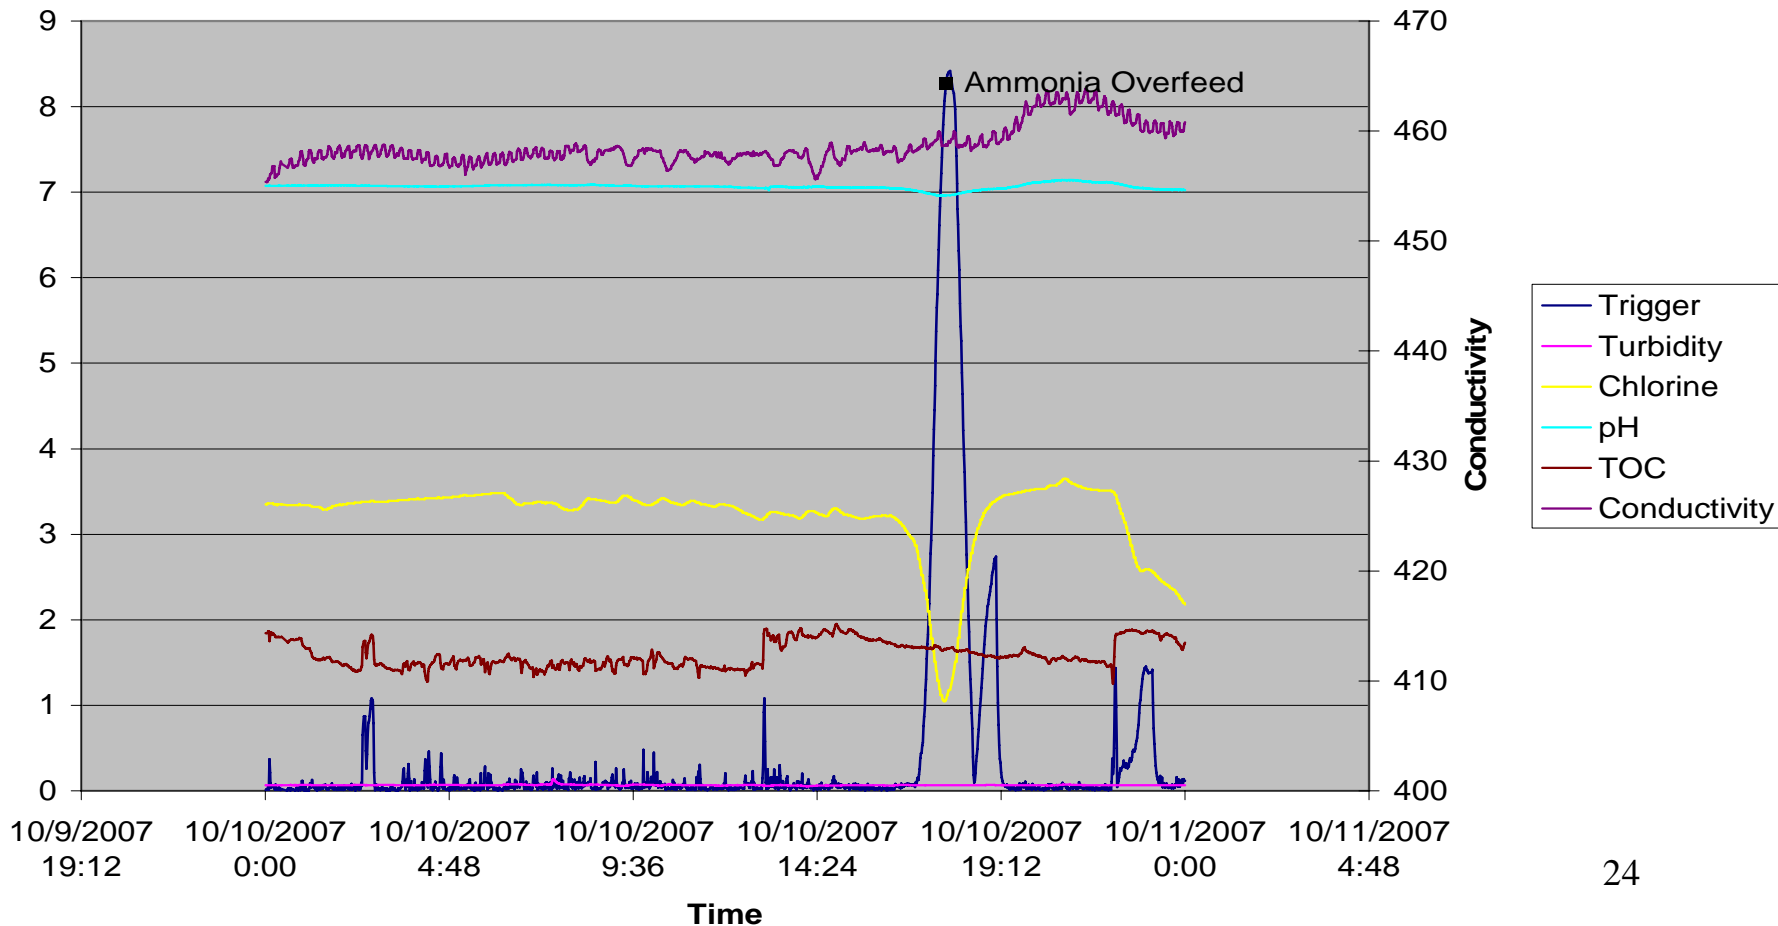
Ammonia Overfeed Caused by SCADA Switchover

On October 10th, 2007 there was another ammonia overfeed caused during the switchover from the old SCADA system to the new. This created a similar drop in chlorine and pH as the October 3rd overfeed.

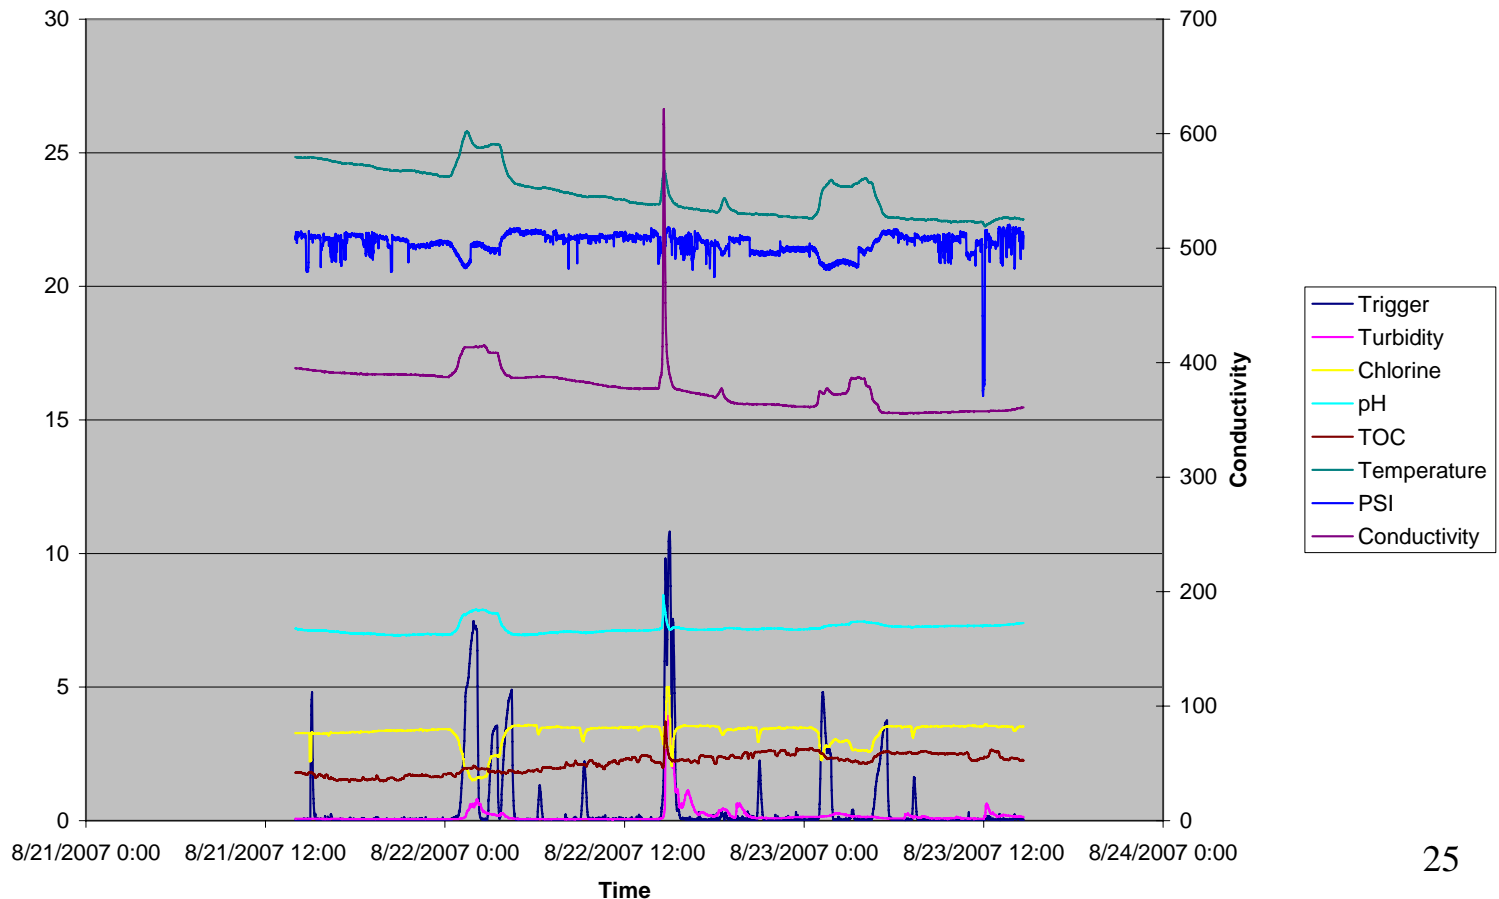
Possible Ammonia Feed Events

Between August 22 and August 23, 2007, three similar events occurred. Increases in turbidity, pH, and possibly TOC with drops in chlorine caused triggers. These changes resemble the large ammonia event that occurred in March. Operator believes these could be ammonia feed events but cannot confirm it with operations.

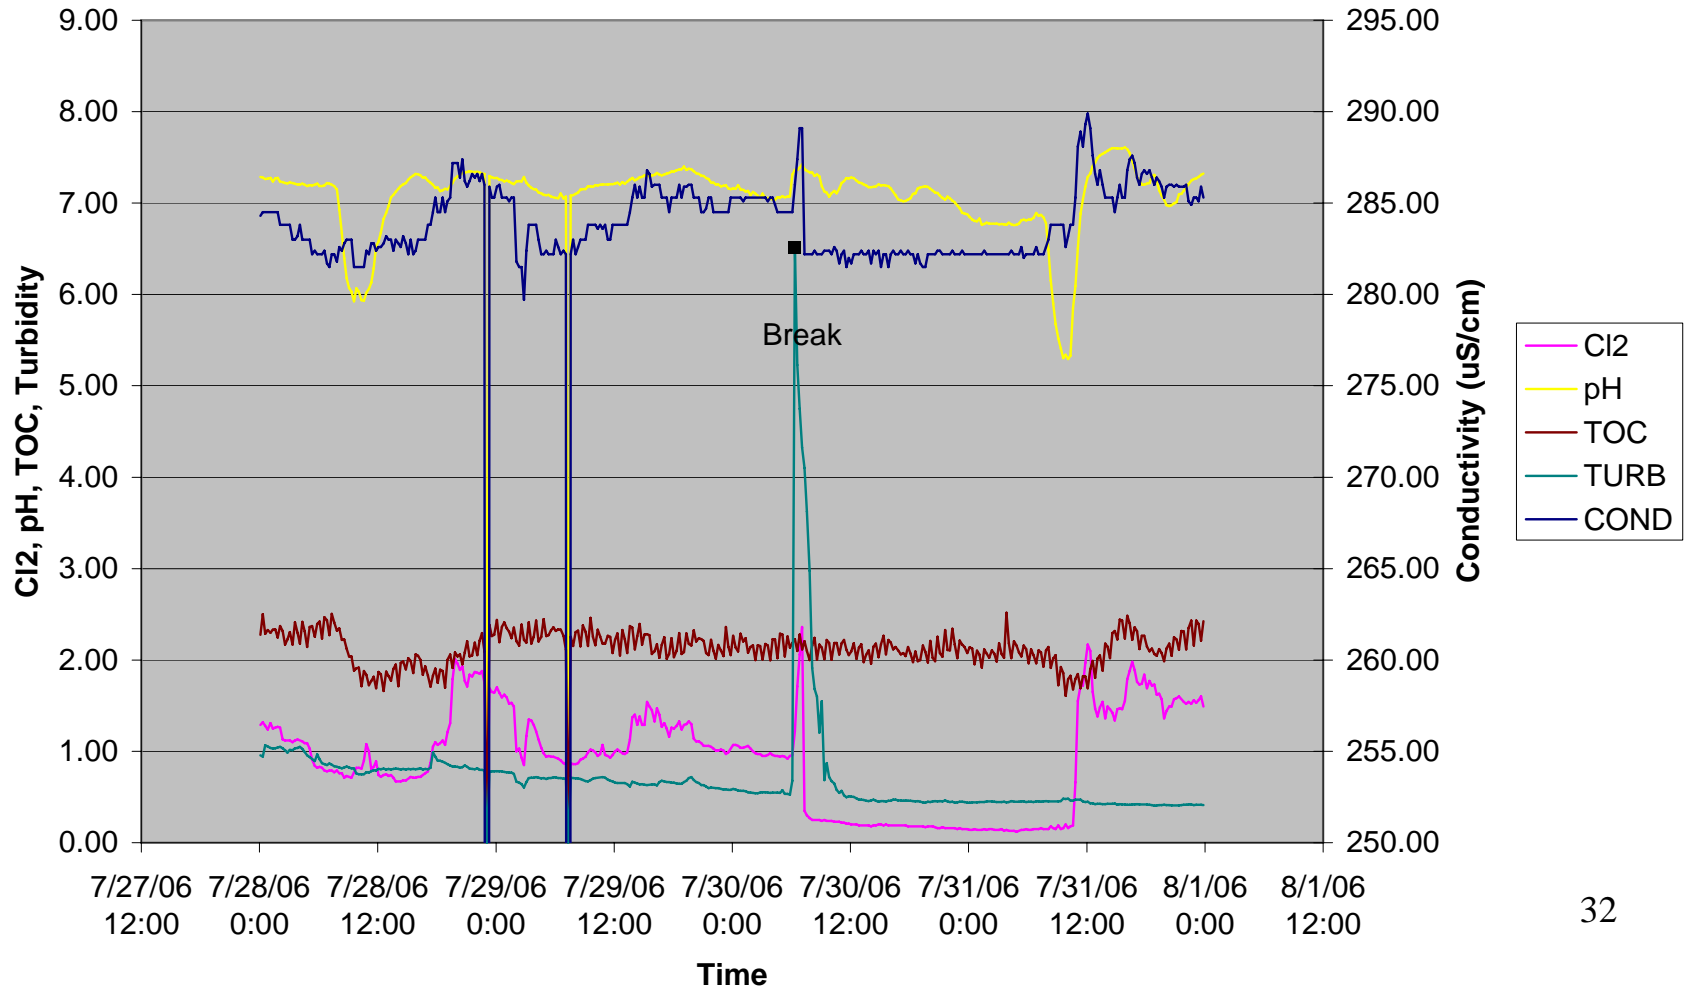
Main Break #2

The break occurred on July 30th, 2006. The line was a 36" water main located 1.0 miles from the WDMP. Conductivity, turbidity, and chlorine spiked. There appears to be two water flow interruptions to the WDMP the night before but it's unclear if they are related to the break on the 30th.

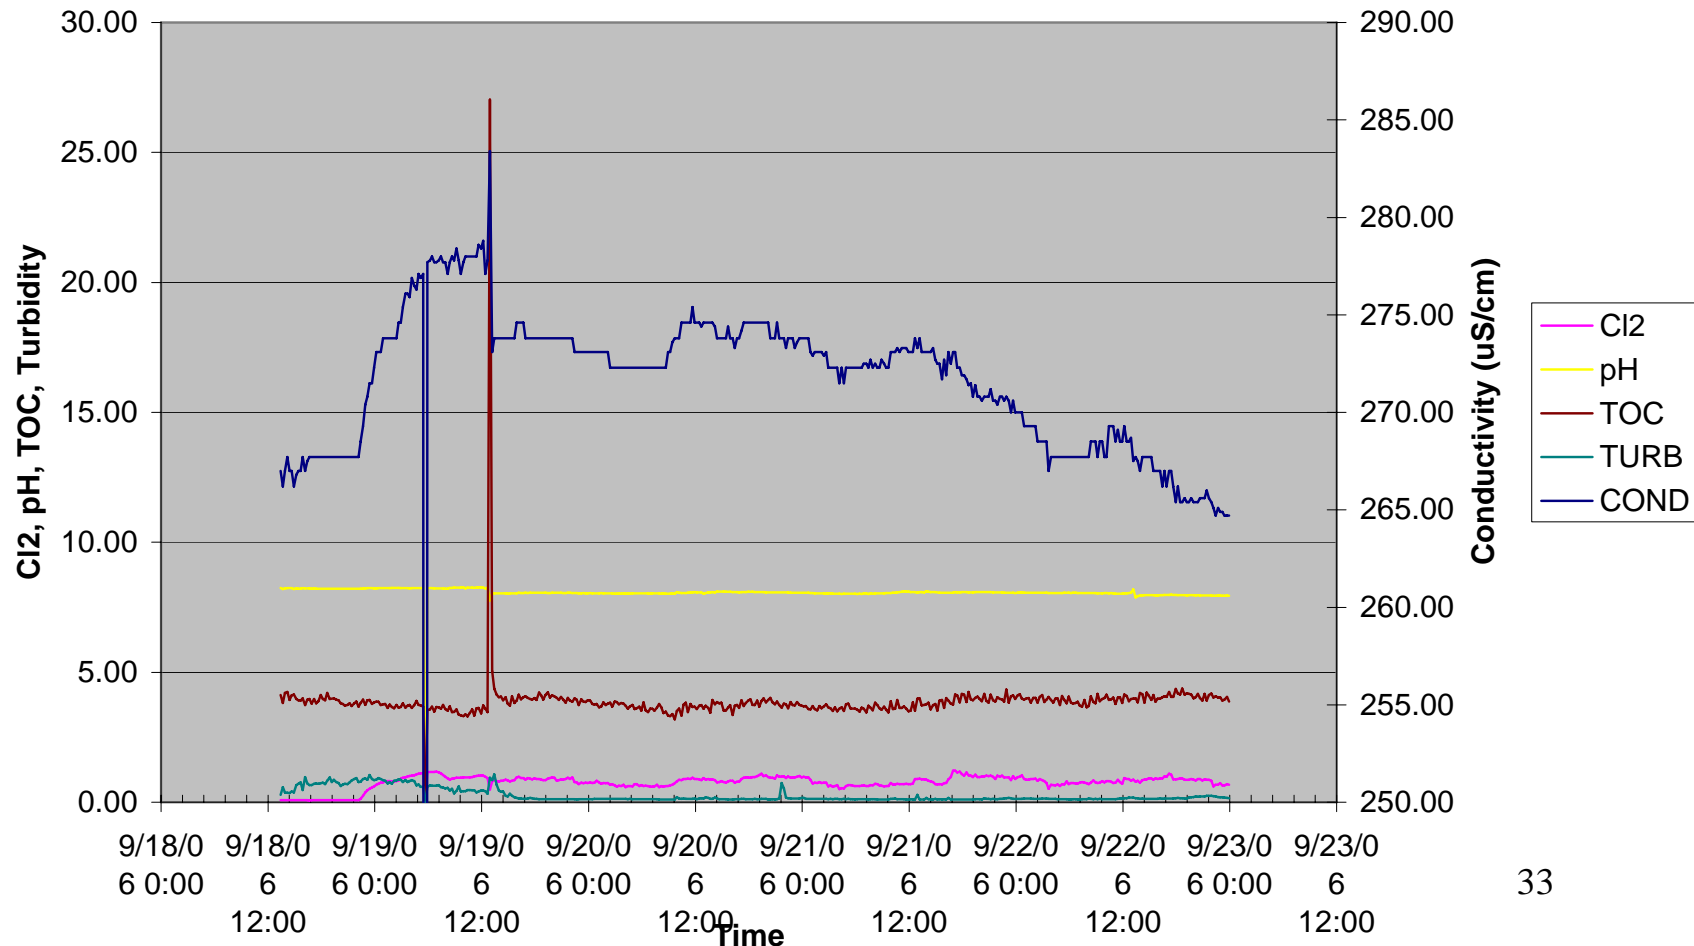
Main Break #3

The break occurred at night on September 20th, 2006. The exact time of the break is currently unknown, although there appears to be a flow interruption to the WDMP the previous morning. The line involved was a 12" water main which is 0.4 miles from the WDMP.

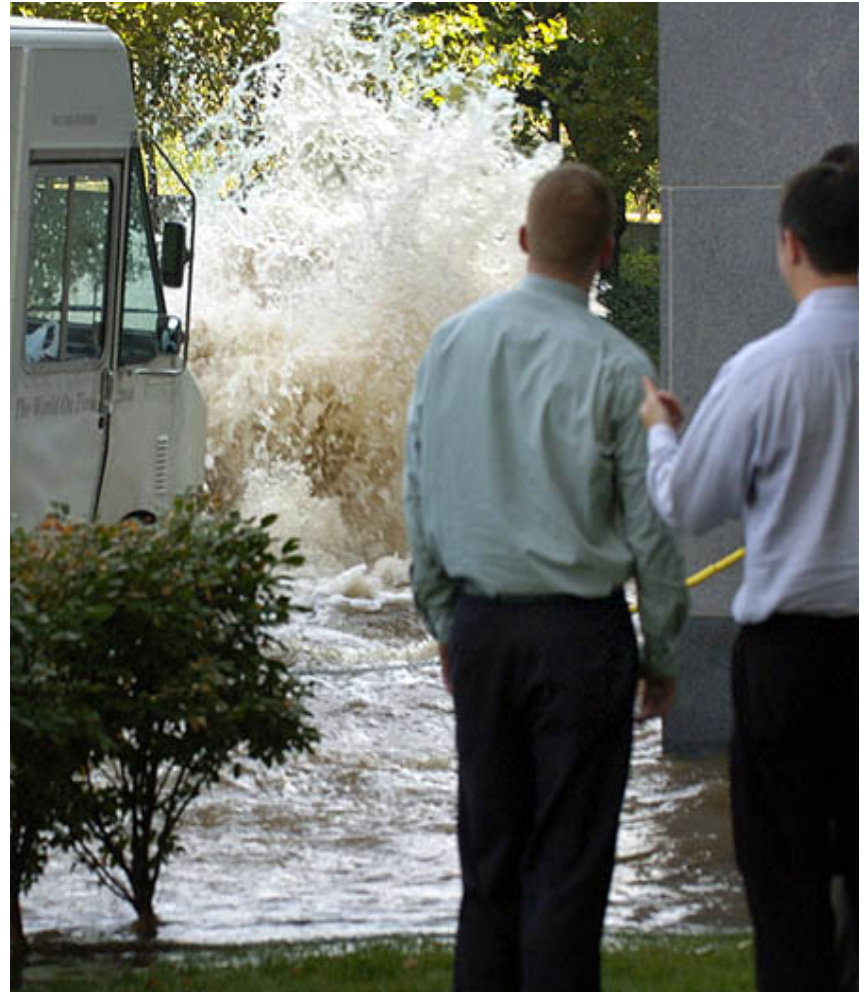
36 Inch Main Break

A geyser caused by a severed 36-inch water line erupts 10:30 a.m., August 17th. One of the largest water main breaks in the city's modern history.

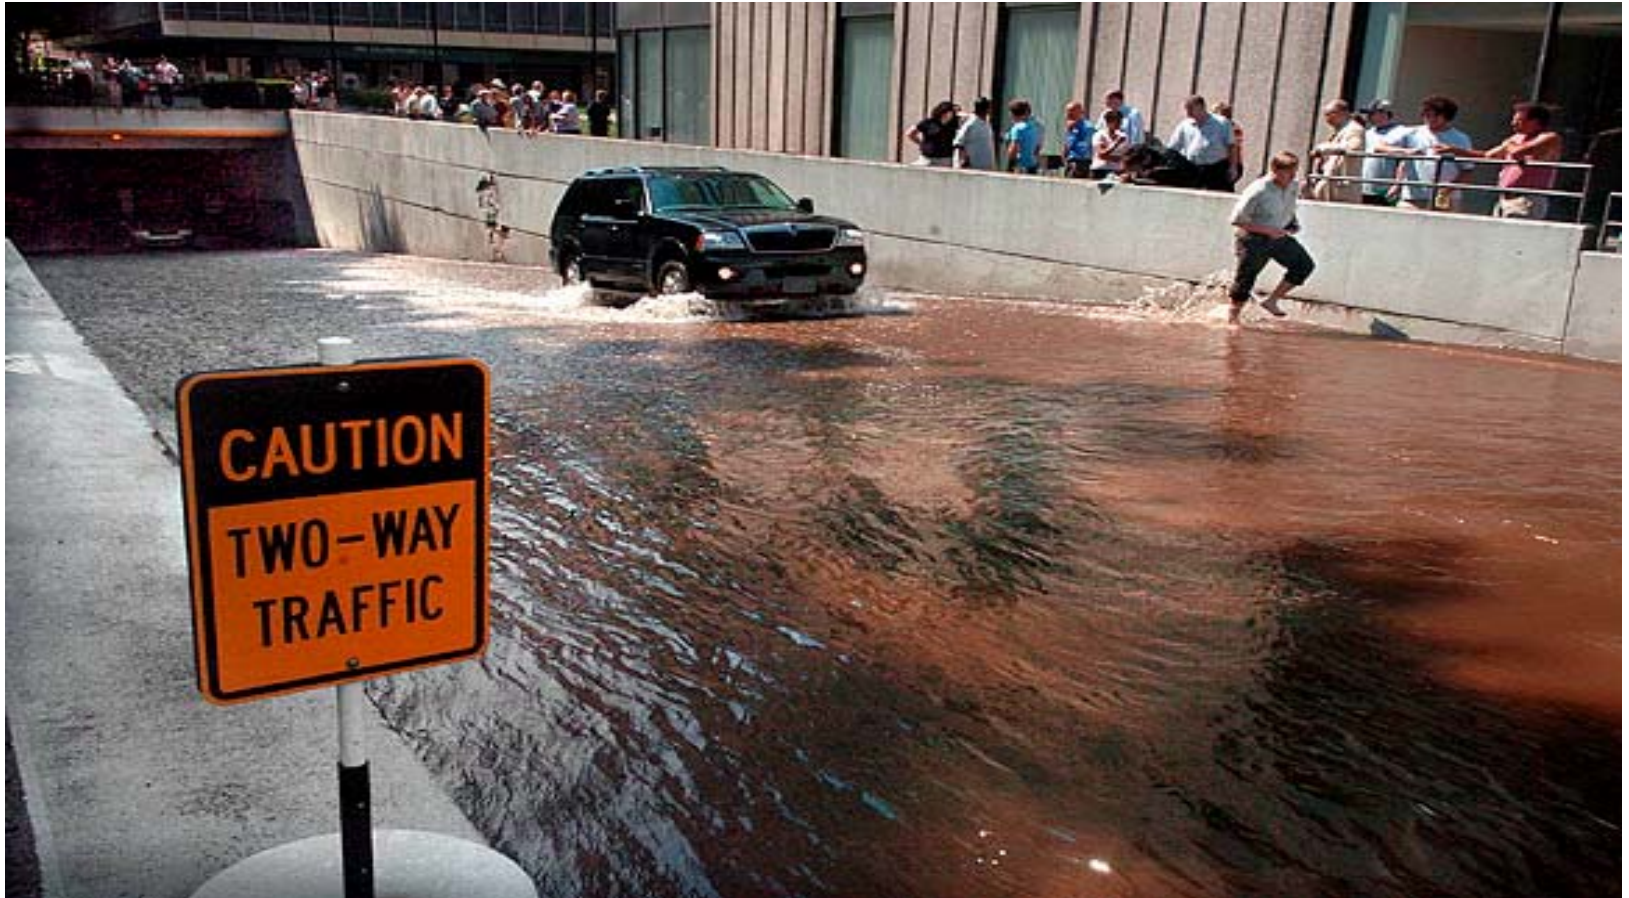
A driver who was able to rescue a vehicle follows a man on foot out of a flooded parking garage, following a water main break

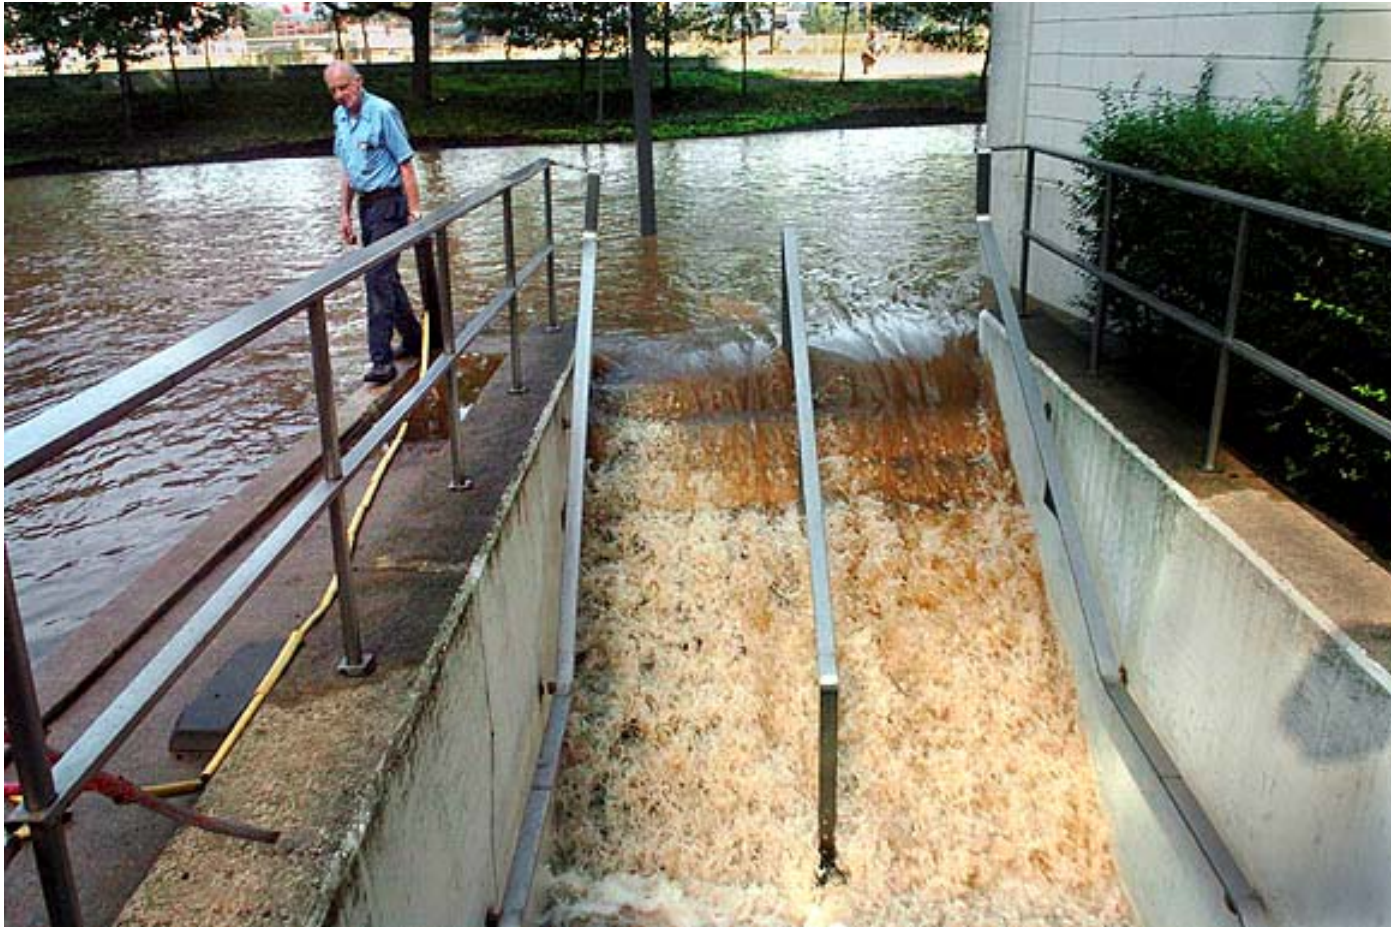
More than 20 million gallons of water poured out and into nearby parking garages and other low-lying areas Downtown.

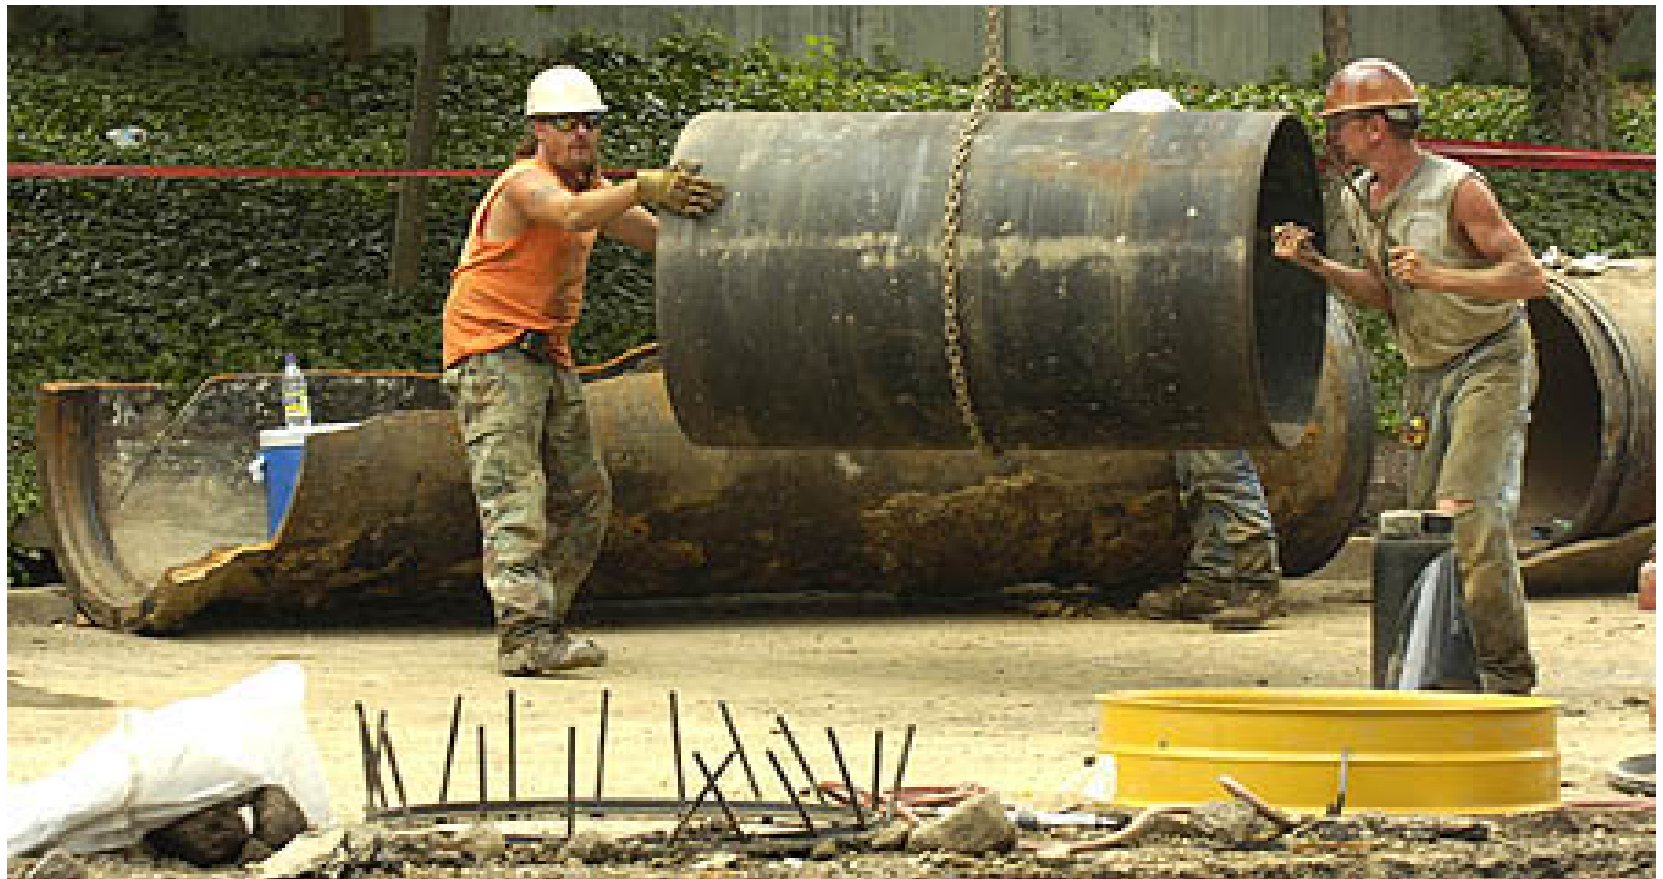
Workers move a section of new pipe into position as the broken 36-inch water main can be seen in the background.
